# Case Study - Warehouse Radiant Barrier Installation

(July 2010)

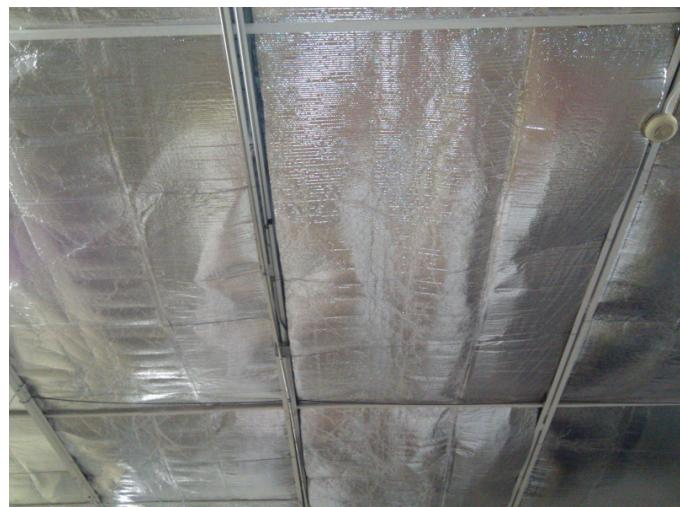
Data loggers were installed in the center of the warehouse at heights of 4ft, 8ft, and 12ft. Temperature readings were collected for 4 days prior to insulating. Double bubble radiant barrier from Energy Efficient Solutions was installed at the bottom of the roof trusses approximately 2 feet below the ceiling. Bailing wire was attached to the bottom surface of the trusses to provide a support structure, and the radiant barrier was laid on top of the wire. The data loggers continued to record data for another week after the installation was complete. The installation took place in Dallas, TX during the month of July when outdoor temperatures commonly exceed 100 F.

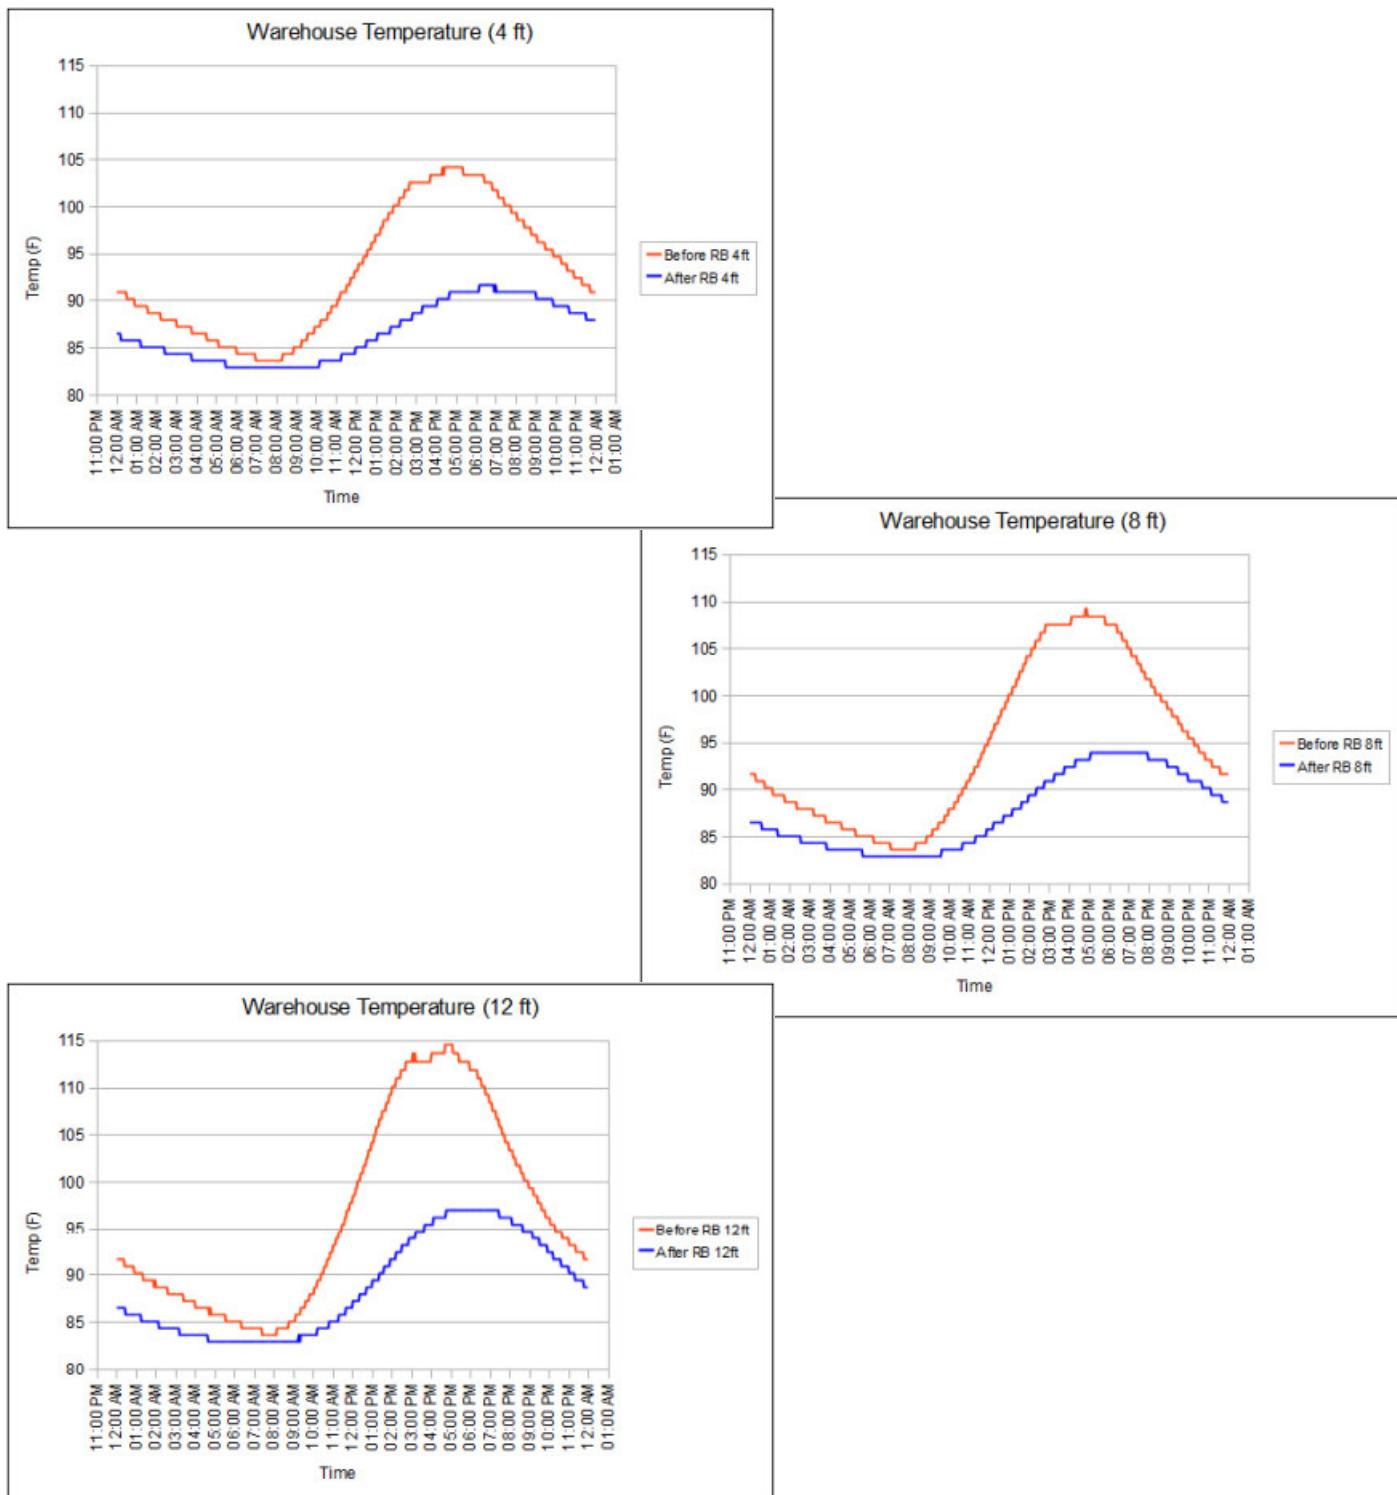
Warehouse Temperature Results			
Height Above Floor	Daily High Before RB (F)	Daily High After RB (F)	Reduction (F)
4 ft	104.2	91.7	12.5
8 ft	109.3	94.0	15.3
12 ft	114.6	97.0	17.6

(See temperature graphs on page 2 for more details.)

Installing radiant barrier is an extremely effective method to reduce summer warehouse temperatures and increase the comfort of a warehouse space. In this particular warehouse, the temperatures were reduced by an average of 15 degrees and even brought the internal temperature down below the outdoor ambient temperature. The radiant barrier has created a more pleasant working environment for warehouse employees.
